Existing Condition of the Bank Stabilization
and Navigation Project Structures,
River Miles 330 and 400

**US Army Corps
of Engineers** ®
Kansas City District

Existing Condition
Of the
Bank Stabilization and Navigation Project Structures
River Miles 330 and 400

March 2016

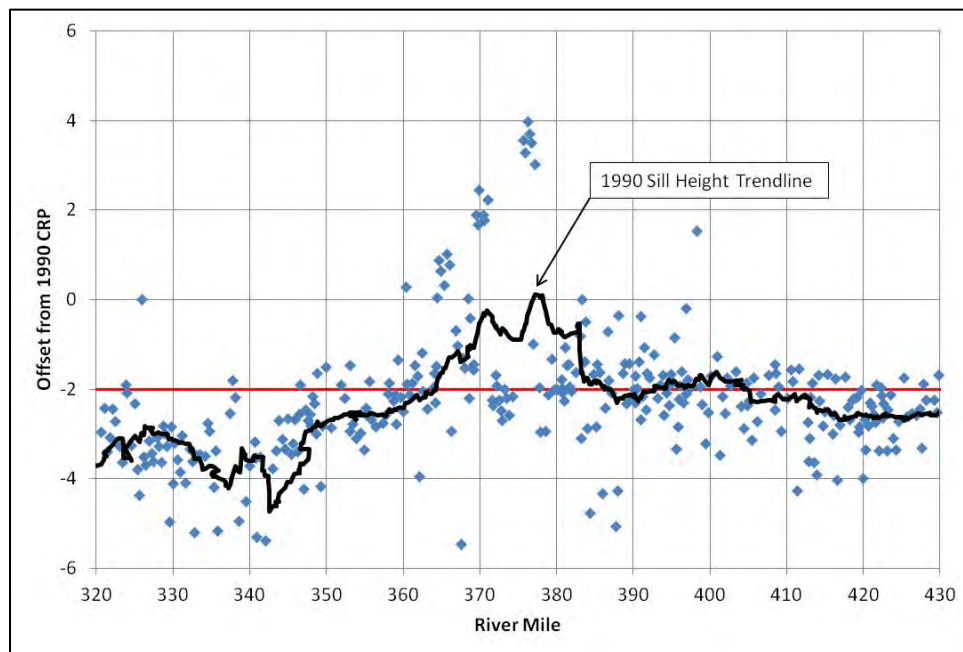
Figure 16. Estimated height of sill in 1990 relative to the 1990 CRP

Figure 16 plots estimated sill heights in 1990 relative to the 1973 SDC and the 1990 CRP. Except for sills between rm 363 to rm 383, the average height of the sills was at or below the 1973 SDC as shown by the trendline. The high elevation sills between rm 363 and rm 383 are the sills repaired in 1980 and 1981 (Figure 14) to correct the navigation problem below the Kansas River.

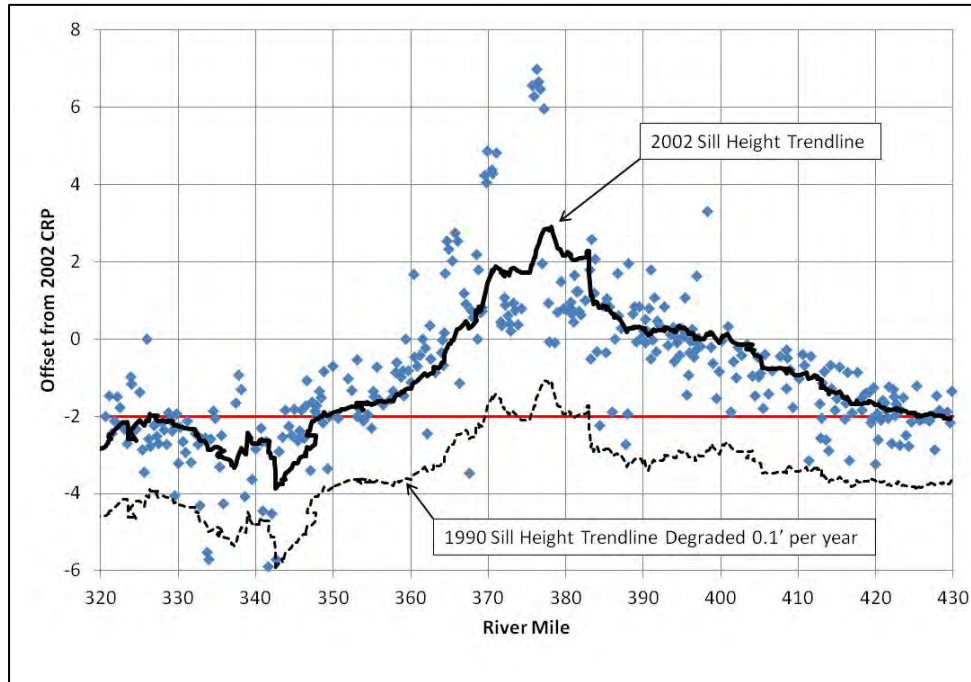
Figure 17. Estimated height of sills in 2002 relative to the 2002 CRP

When the CRP was revised in 2002, the height of the sills increased relative to the 1973 SDC (Figure 17). The ‘1990 Sill Height Trendline Degraded 0.1’ per year’ in Figure 17 is the estimated height the sills would have been in 2002 had the CRP not been revised due to falling WSP. The delta between the ‘1990 Sill Height Trendline Degraded 0.1’ per year’ and the ‘2002 Sill Height Trendline’ represents the perched

condition of the sills due to falling CRP elevations. Thus, by 2002, the sills were perched due to falling CRP elevations, not due to intentional SDC deviations.

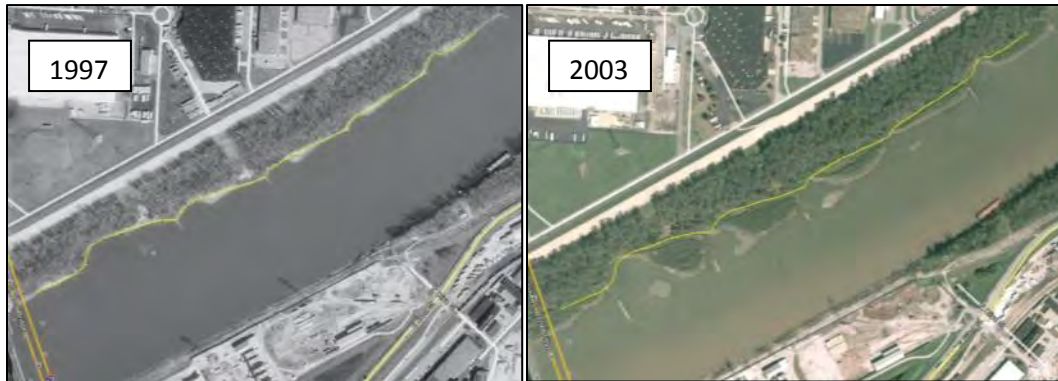
Figure 18. Accretion and vegetative encroachment between 1997 and 2003 at rm 364

The negative effects of the perched condition of the structures from 1993 until around 2000 was somewhat masked by the unusually high flow during the period. With the return of normal or low flow after 2001, the accretion induced by the perched structures became exposed and covered with woody vegetation (Figure 18).

The accretion process in Figure 18 results in the loss of aquatic habitat as the woody vegetation traps additional sediments and gradually transforms open river into high bank. In 2002 the Corps was constructing shallow water aquatic habitat as part of the Missouri River Mitigation Project (MRMP). The Corps was also obligated to comply with the 2000 Fish and Wildlife Service's Biological Opinion on the Operation and Maintenance of the BSNP (BiOp) which required the preservation of existing shallow water aquatic habitat and the creation of up to 19,565 acres of new aquatic habitat. Since the accretion process in the subject reach and resulting loss of shallow water aquatic habitat was at odds with the objectives of the MRMP and the BiOp, the structures in the subject reach became prime candidates for notching and lowering.

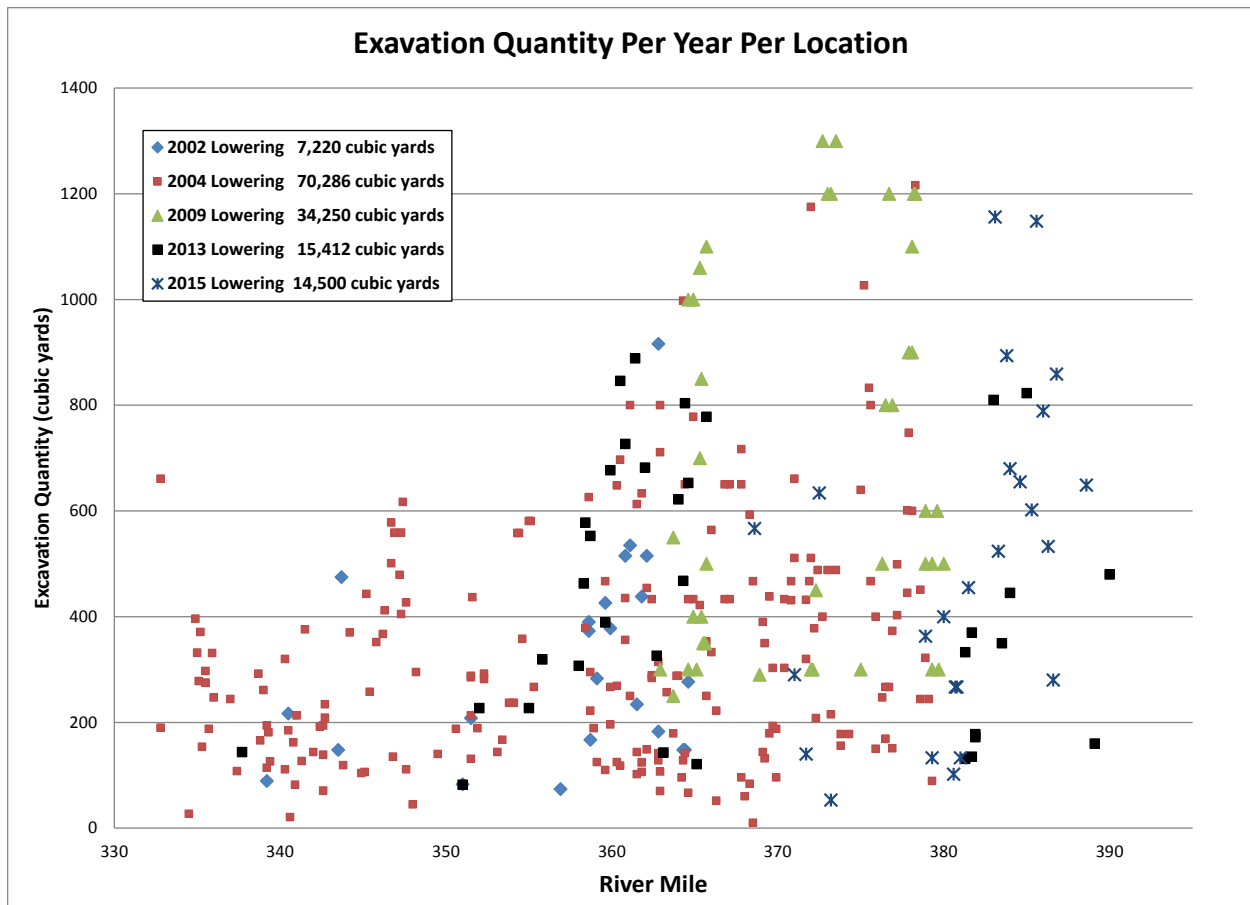
Figure 19. Structure lowering quantities.

The same selection process was followed in 2004, 2009, and 2013. Figure 19 shows the location, quantity, and year of lowering.

Structures lowered in 2002 and 2004 were lowered relative to the 2002 CRP; structures lowered in 2009 were lowered relative to the 2005 CRP; and structures lowered in 2013 were lowered relative to the 2010 CRP. Since the CRP was declining during this period, some of the structures previously lowered were lowered further in 2004, 2009, and 2013. In other cases, additional, usually landward, portions of the same structures were lowered, or previously non-lowered structures were lowered. Due to the multiple iterations of lowering of each structure, and the segmented approach to lowering (selected segments of each structure lowered each time rather than the whole structure lowered) each point on the graph does not represent an entire structure and each structure is not represented by one point.

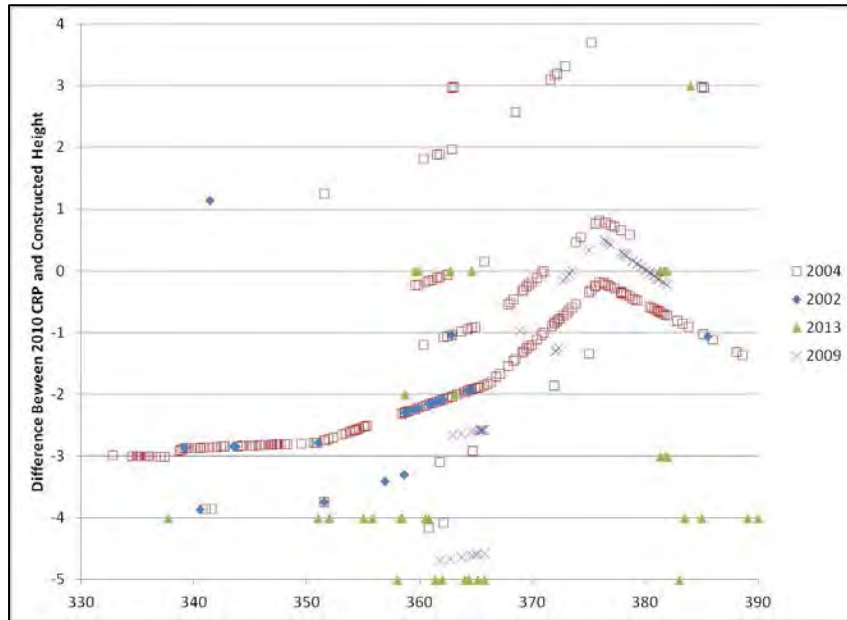
Figure 20. Finished crown height of lowered structures relative to 2010 CRP

Since structure heights are measured from the CRP elevation, the height of previously lowered structures change every time the CRP elevations are revised. As the CRP elevation trend in the subject reach is downward, with each CRP elevation revision, the height of previously lowered structures increased. It is therefore useful to plot the height of all lowered structures relative to the current CRP (Figure 20). Since lowering is always to increments of whole numbers, and the CRP elevation did not decrease uniformly across the subject reach, the heights plot in horizontal bands that trend vertically opposite the CRP trend. Thus, for example, structures lowered in 2004 at rm 335 to -3 CRP are still at -3

CRP when evaluated against the 2010 CRP, but structures lowered in 2004 at rm 377 to -3 CRP are now at -0.03 CRP when evaluated against the 2010 CRP. The vertical separation between the bands for each year of lowering is due to rounding to whole numbers and due to the different lowered height for the different types of structures.

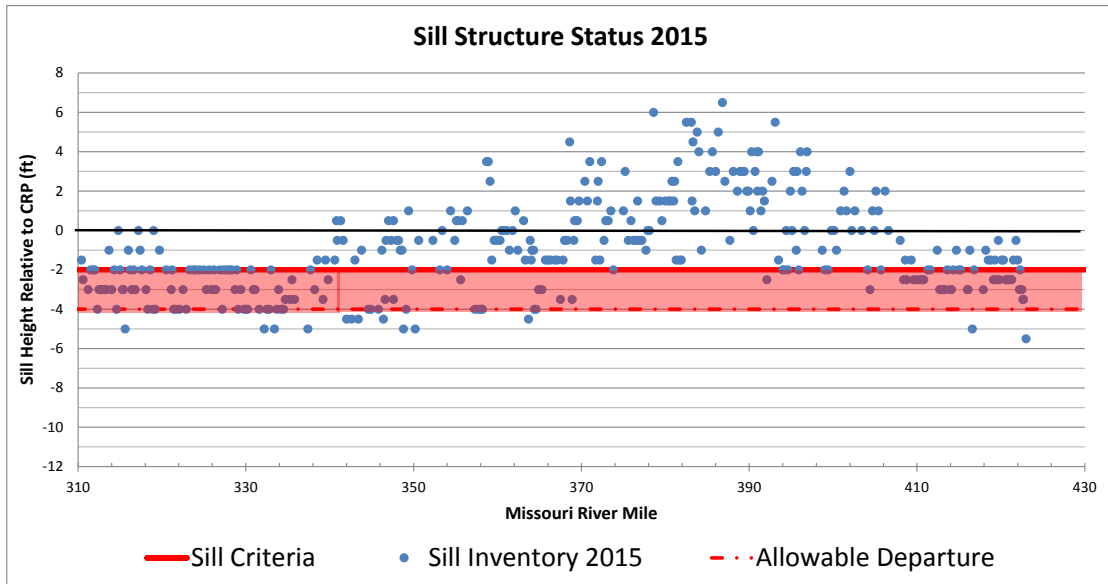
Figure 21. Sill heights in 2015.

Figure 21 plots the height of all sills. As seen in the graph, almost all sills are above criteria.

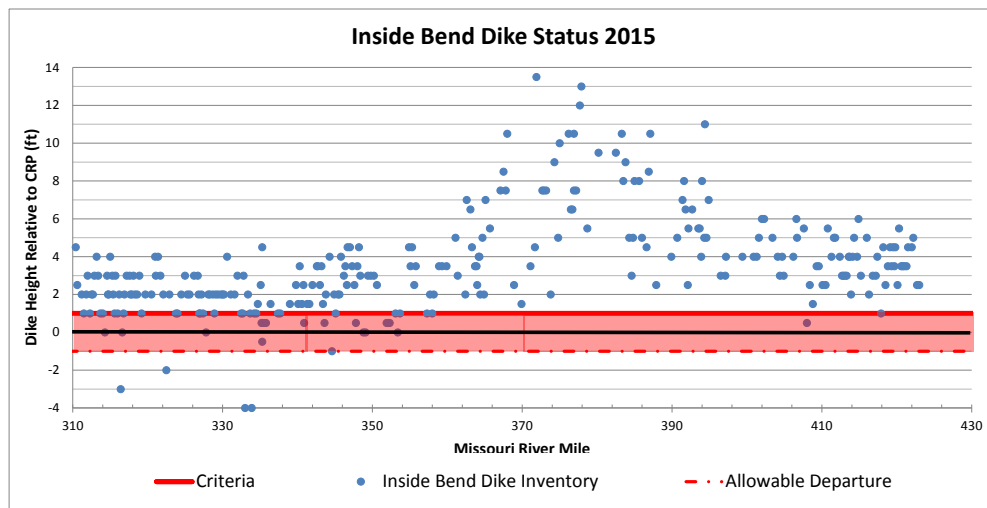
Figure 22. Inside Bend dike heights in 2015.

Figure 22 and Figure 23 plot the height of inside bend dikes and outside bend dikes. Dike heights are generally above criteria.

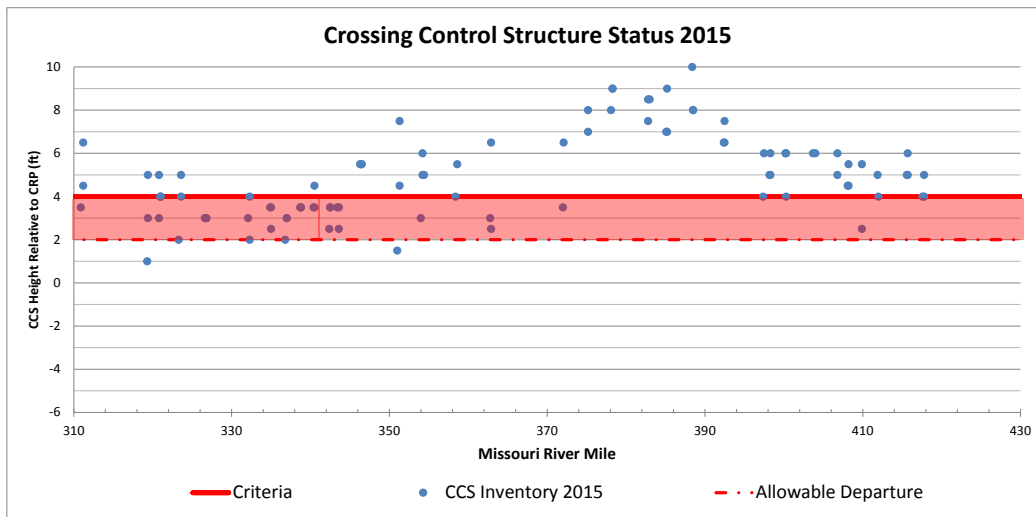
Figure 24. Crossing control structure heights in 2015

Figure 23 plots the height of crossing control structures (CCS). CCS heights are on average above or within criteria over the entire study reach.

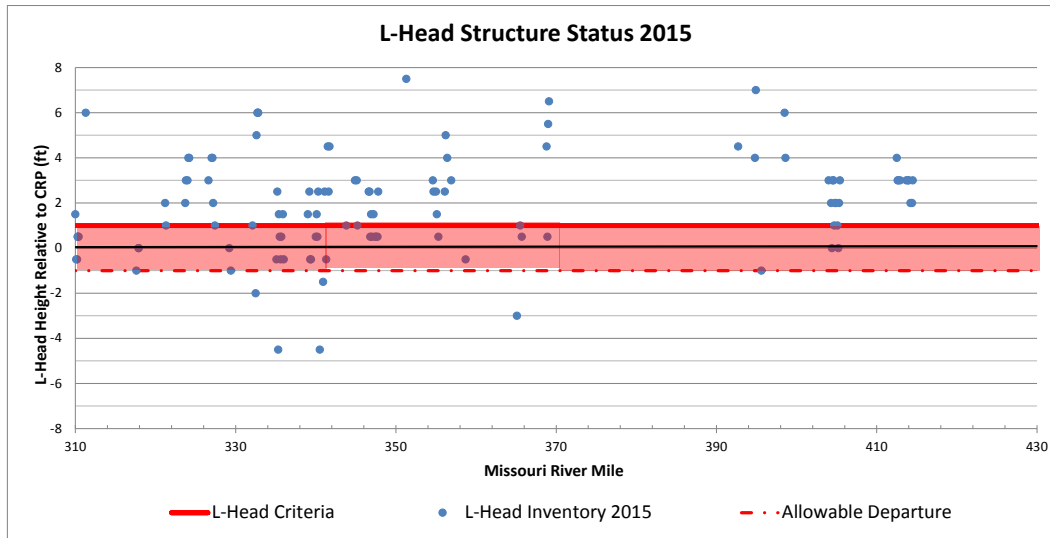
Figure 25. L-head revetment heights in 2015.

Figure 24 plots the height of L-Head revetments. L-Head revetment heights are on above criteria over the entire study reach.
