Appendix H

Analysis of the Cost of Bed Degradation of the Bed
of the Missouri River to the Missouri River Bank
Stabilization and Navigation Project (BSNP)

MEMORANDUM FOR RECORD

SUBJECT: Analysis of the Cost of Degradation of the Bed of the Missouri River to the Missouri River Bank Stabilization and Navigation Project (BSNP)

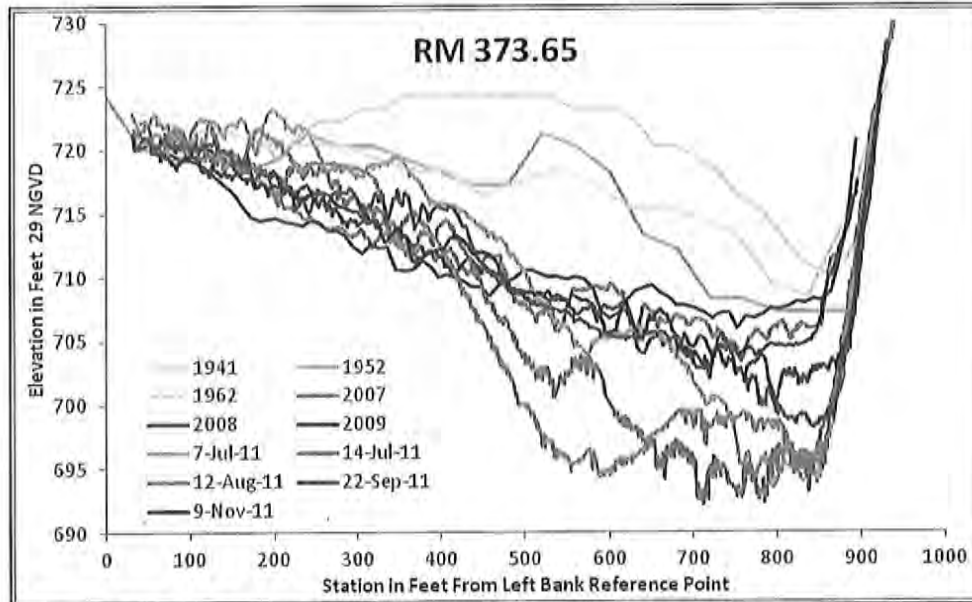
a. The bed elevation along the toe of the outside bend revetments drops and undermines the revetments (Figure 1). The stone fill in the revetment then self-launches, resulting in an over-steepened riverward slope. The over-steepened slope is less stable, more likely to fail, and requires reinforcement with additional stone fill. This is a direct consequence of bed degradation as the toe of a revetment is supported by the bed.

Figure 1: Example of lowering of river bed next to revetment toe.

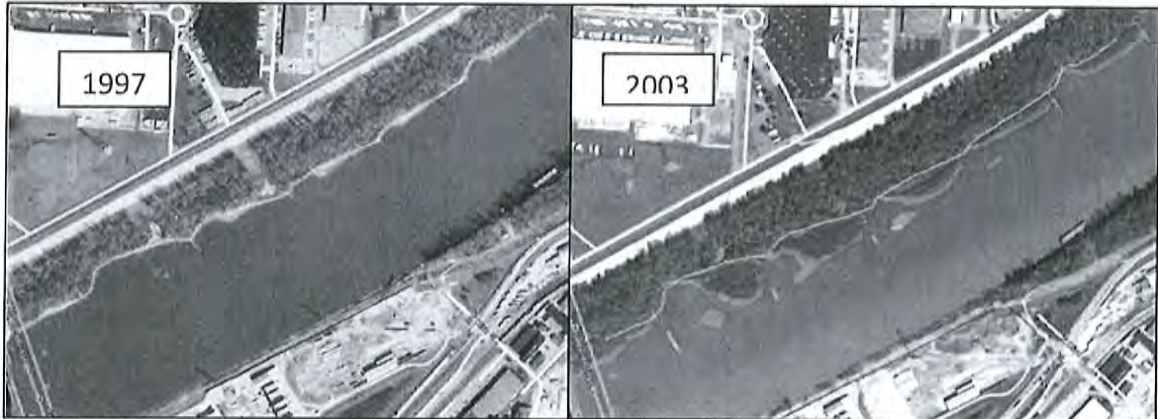
b. The crown elevation of the dikes and L-heads become perched above their design elevation. This is a secondary impact of bed degradation as bed degradation affects the water surface of the Construction Reference Plane (CRP), which is the plane by which structure heights (elevation) are referenced. The perched condition of the structures reduces the over-topping frequency of the structures which leads to a build-up of sediment between the structures. The sediment vegetates, which slows the water flowing over the vegetation which then leads to more deposition during flood events. The result is a loss of aquatic habitat and reduced flow conveyance (Figure 2). The perched structures must be lowered by mechanical removal of the stone fill.

Figure 2: Example of accretion and vegetation (river mile 364) caused by perched structures.

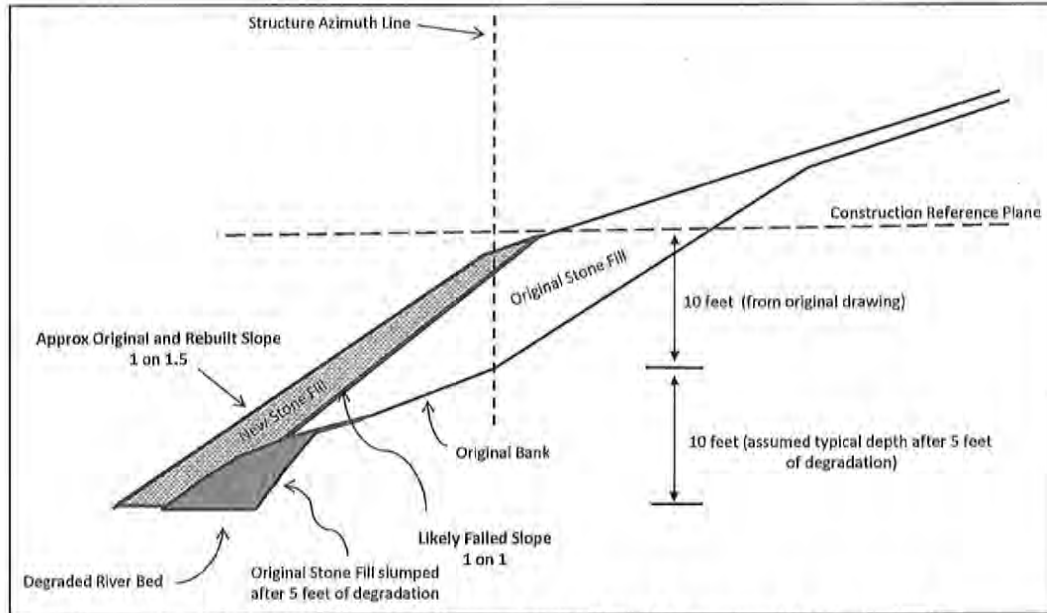
(2) The lower riverward slope of a TTR is constructed at a grade of 1:1.5 (V:H) which extends from the toe up to the structure azimuth line. This analysis assumes that as the bed degrades, the riverward slope of the TTR steepens until the slope reaches a 1:1 slope. The 1:1 slope is assumed to extend vertically up to the CRP elevation at which point the 1:1 slope would be visible during low water inspections. The 1:1 slope is steeper (over-steepened) than the constructed minimal slope of 1:1.25 and is assumed to be near the slope angle at which the structure is no longer stable. At this point, the revetment is assumed to be reinforced by adding stone fill until the slope is once again a 1:1.5 slope. The calculated amount of rock needed for this repair is reduced by 37% to account for the quantity of pre-existing rock that slumped to the toe of the degraded revetment. See Figure 6 for a schematic of a typical failed and repaired TTR. The quantity of stone fill needed is calculated for one foot of degradation per mile of river.

Figure 6: Typical Cross Section of Failed and Repaired Revetments

a. **Revetment Reinforcement.** The volume of rock needed for revetment reinforcement per river mile per foot of degradation, 9,678 tons, was multiplied by the 10 year average contract price for rock placement of \$35 per ton. The result is \$320,000 per river mile, per foot of degradation.

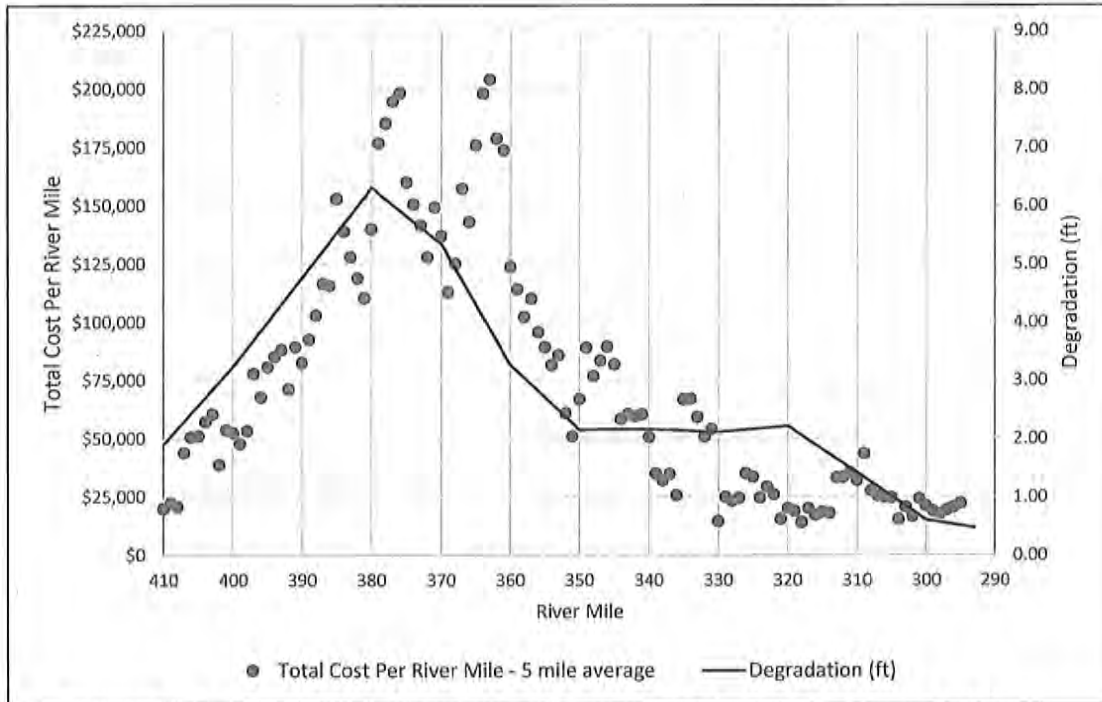
Figure 7: Costs to Lower Structures Compared to Amount of Degradation

b. **Structure Lowering.** The total volume of rock removed to date and the total volume of rock calculated remaining to be removed is 141,000 cubic yards and 258,000 cubic yards respectively. The total volume per river mile was divided by the number of feet of degradation per river mile. This value was then averaged and multiplied by the contract price for rock removal obtained over the last 10 years, which is \$22 per cubic yard. The result is \$18,000 per river mile, per foot of degradation.
