Existing Condition of the Bank Stabilization
and Navigation Project Structures,
River Miles 330 and 400

**US Army Corps
of Engineers** ®
Kansas City District

Existing Condition
Of the
Bank Stabilization and Navigation Project Structures
River Miles 330 and 400

March 2016

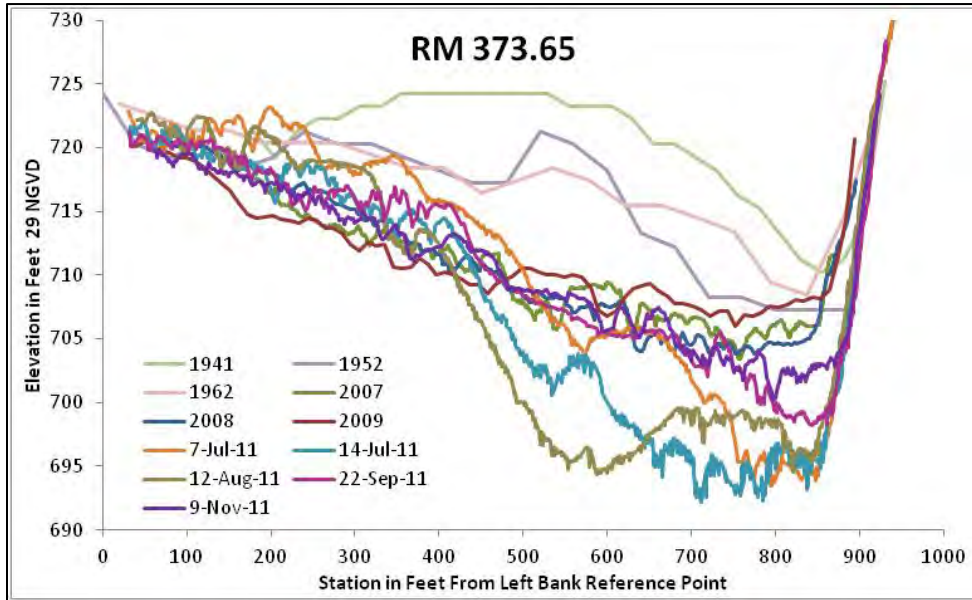
Figure 4. Cross section comparison at rm 373.65

Due to the lack of survey data in a digital format prior to 1998, direct comparison of bed elevations for multiple years prior to 1998 has only been completed at a few locations. Figure 4 and Figure 5 show two such comparisons.

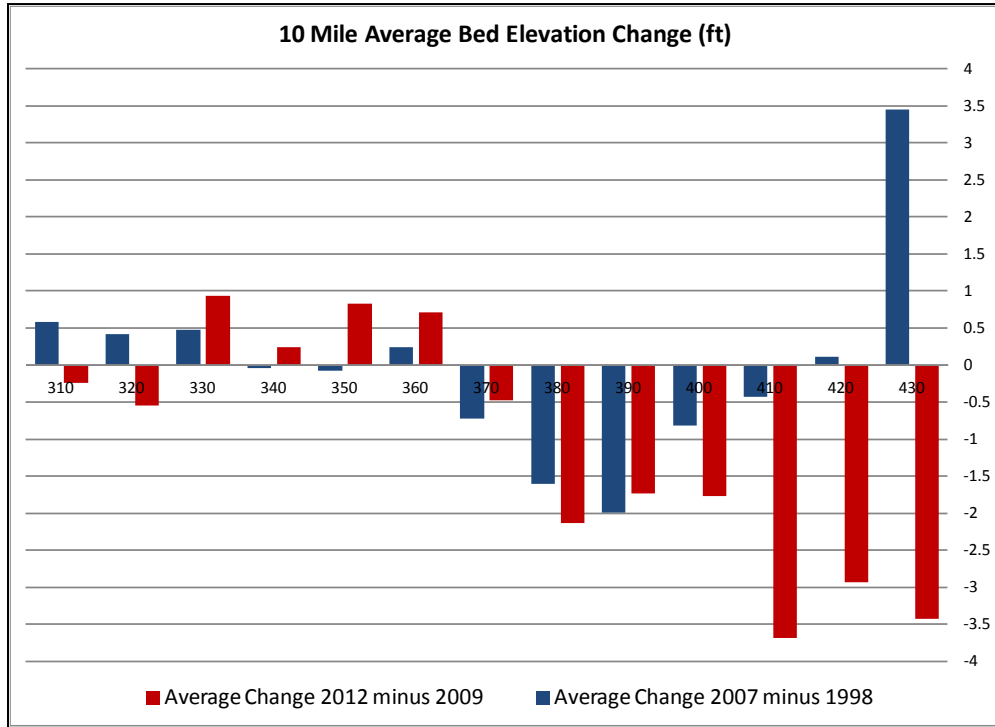
Figure 6. Ten mile average bed change for selected surveys

Survey comparisons over the entire spatial extent of the subject reach were completed for the following surveys; 1998 and 2007, 2009 and 2012 (Figure 6), 1987 and 2009, 1987 and 2011 (Figure 7). The 1987 hardcopy data was manual entered into an electronic format.

Hydrographic survey data and WSP follow similar trends when analyzed over multiple years and multiple river miles. While degradation has occurred over the entire subject reach since 1990, the degradation is most severe upstream of rm 360 and appears to be moving in an upstream direction. Degradation downstream of rm 360 appears to have slowed or perhaps temporarily stabilized.

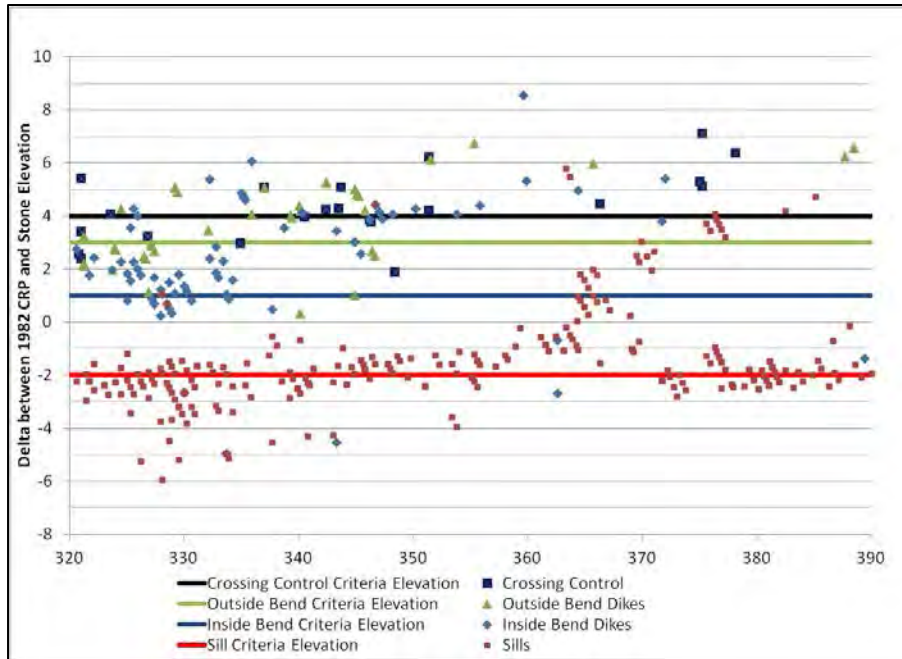
Figure 12. Finished crown heights of maintained structures, 1973 to 1990

BSNP structures require continual maintenance independent of bed elevation changes. Hydraulic forces, boat impacts, shoaling problems, and other factors cause structures to require repair or other modifications. Figure 12 shows the finished crown heights of all dikes, sills, and crossing control structures maintained in the subject reach after 1973, the first known publish date of the current SDC, and before 1991, the end of the relatively stable river period. Heights are referenced to the 1982 CRP which was the CRP in effect during the middle of this period. Each point on the graph represents one maintenance action on one structure in one year. Some of the same structures received multiple actions during this time period so that one structure may have multiple points on the graph. The revetments were not evaluated since they run parallel to the current and have a lesser impact on the active river bed.

As is evident in Figure 12 and Figure 13, some of the structure heights intentionally deviated from the 1973 SDC. Most of the intentional deviation was between rm 360 and rm 380 where the Federal Levees are in close proximity to the river and where the navigation channel experienced shoaling due to the confluence of the Kansas River and the unusually straight reach immediately downstream. The intentional deviation was to rectify the navigation issue and to protect the levee foreshore from river induced bank erosion during flood events.

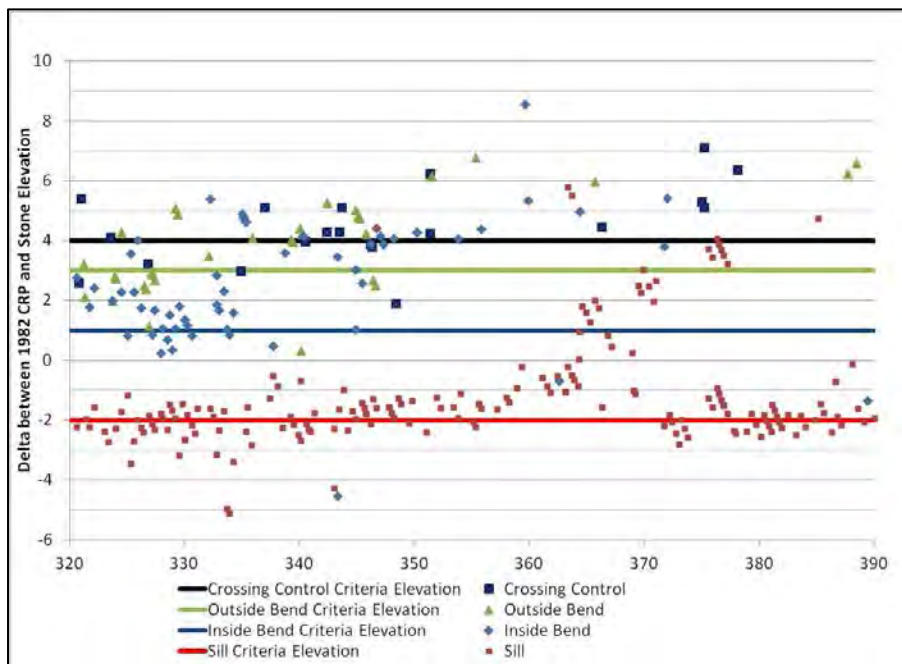
Figure 13. Finished crown height of the most recent iteration of repair, 1974 to 1990

The data in Figure 12 was thinned to show only the height for the most recent maintenance action as of 1990 for each portion of all maintained structures (Figure 13).

Table 3 shows the percent of structures in Figure 13 where the crown height exceeded the SDC by more than 1 ft. One foot of tolerance was chosen due to rounding to whole numbers in the database.

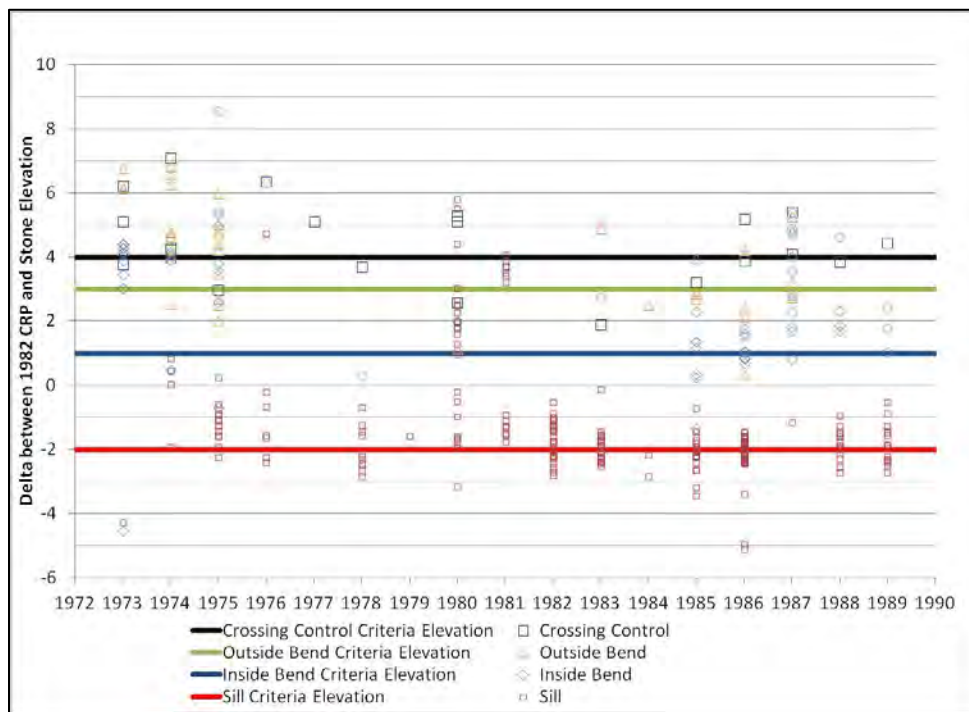
Figure 14. Structure repair height by year and by type of structure

Figure 14 shows the finished height of all repairs by year during this time period. Note that most sill repairs that exceeded the 1973 SDC were constructed by 1982 and a small number of inside bend dike repairs that exceeded the 1973 SDC were constructed between 1985 and 1988.

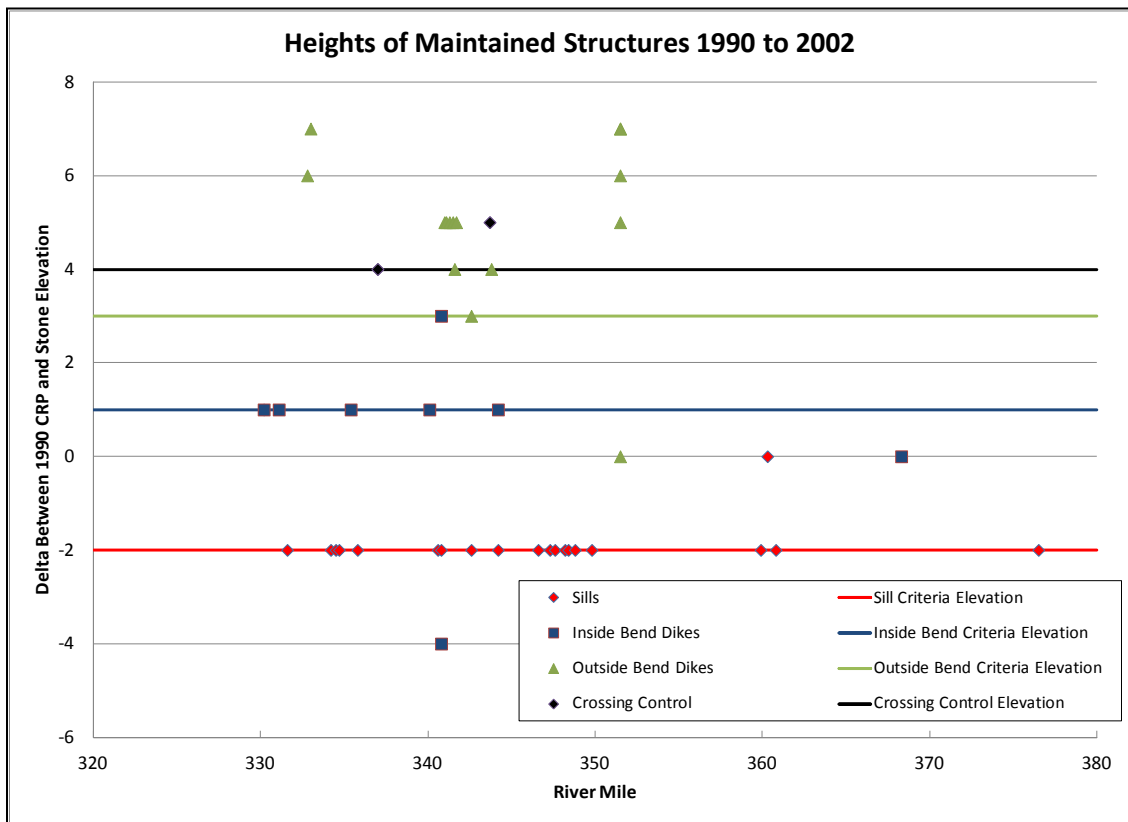
Figure 15. Finished heights of maintained structures, 1990 to 2002

As shown in Figure 8, CRP elevations dropped fairly rapidly after 1990. This period experienced higher than normal flows that includes the 1993 flood. There were 50 structure repairs during this period. As shown in Figure 15, almost all the inside bend dikes and sill repairs were to criteria, and 9 outside bend dikes were repaired above criteria. The outside bend dikes repaired above criteria were at the location of 1993 flood scour holes and the intentional SDC deviation was to prevent further overbank scour in the event of subsequent high water. The revetments were not evaluated in Figure 15 since they run parallel to the current and have a lesser impact on the active river bed.
