Geotechnical Analysis of Flood-Risk Management Projects

Geotechnical Analysis of Flood Risk Management Projects

February 7, 2017 Draft
U.S. Army Corps of Engineers
Kansas City District
Geotechnical Branch
Geotechnical Design and Dam Safety Section

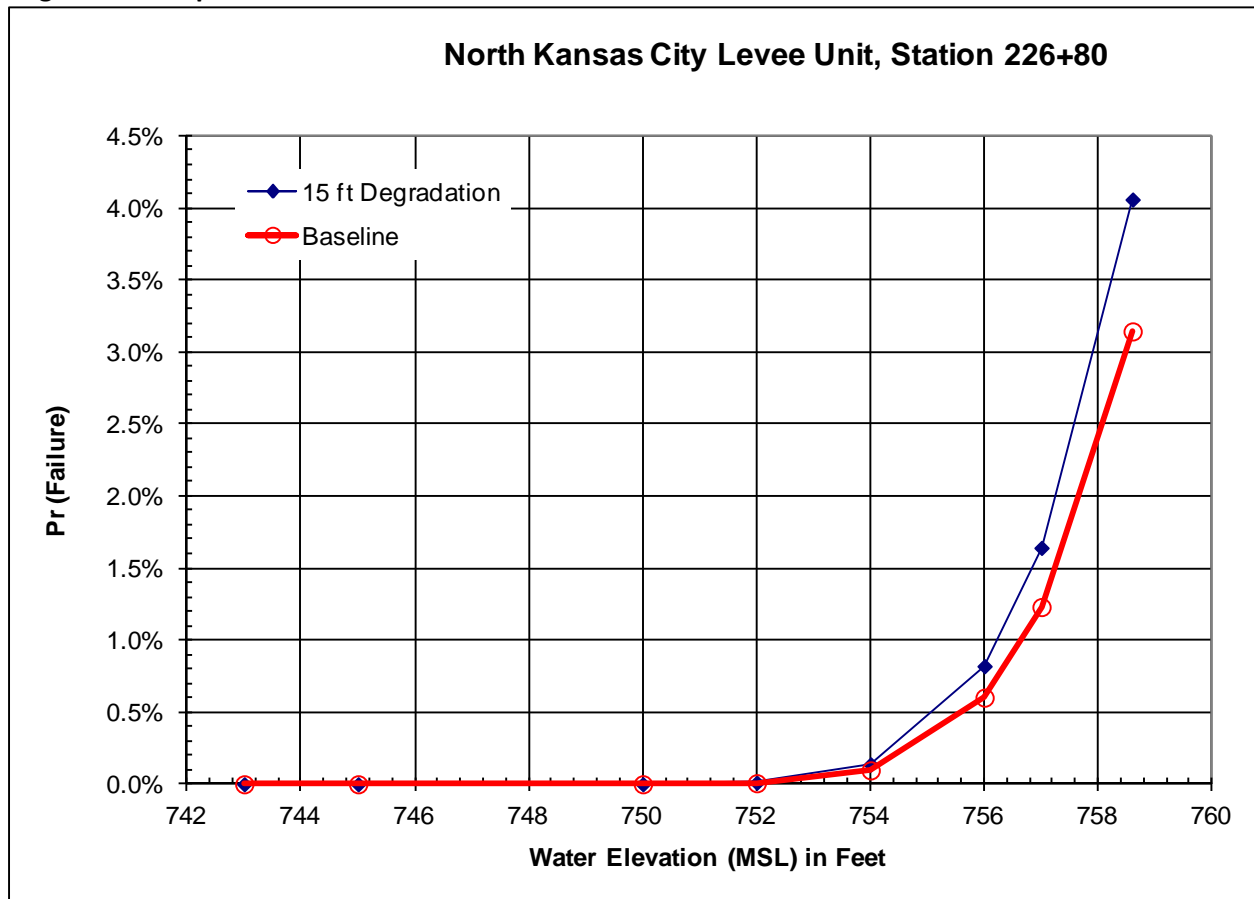
Figure 2.5.1-1: Underseepage Fragility Curve for North Kansas City Levee at Station 226+80 to Quantify Degradation Impact

The baseline Probability of Failure (PoF) for this area is 3.2% with water at the top of the levee. In this analysis, a worst case scenario of river degradation in this area was assumed to be approximately 15 feet. It is assumed that riverbed degradation leads to foreshore reduction proportional to the existing channel bank side slopes of 3 H: 1V; as a result, 15 feet of degradation leads to approximately 45 feet of foreshore loss. All other inputs in the underseepage analysis remain the same as the base condition to isolate the increased risk due to river degradation. The probability of failure for this area after 15 feet of degradation is 4.1% with water at the top of the levee.

The PoF vs. river elevation curves for the baseline and degradation conditions are shown in **Figure 2.5.1-1**. As seen, the increase in underseepage risk to the levee caused by river degradation is insignificant. Furthermore, the underseepage assessment assumes a worst case scenario that all 15 ft of degradation occurs at once or degradation progresses without repairs. Based on the 2011 flood event, the North Kansas City levee (station 45+00) was repaired immediately after the flood event under PL 84-99. The Fairfax-Jersey Creek levee (station 21+27) was armored with riprap during the 2011 flood event with additional riprap placed in 2014 during stabilization of the Jersey Creek Sheetpile Wall. As a result, all the identified initial critical areas of possible underseepage concern were screened out and not considered in the future without project conditions that assess degradation impacts on underseepage performance. Calculations are included in Enclosure A.2. It was assumed that the non-Federal levees would perform adequately compared to the Federal levees because they are relatively short and have

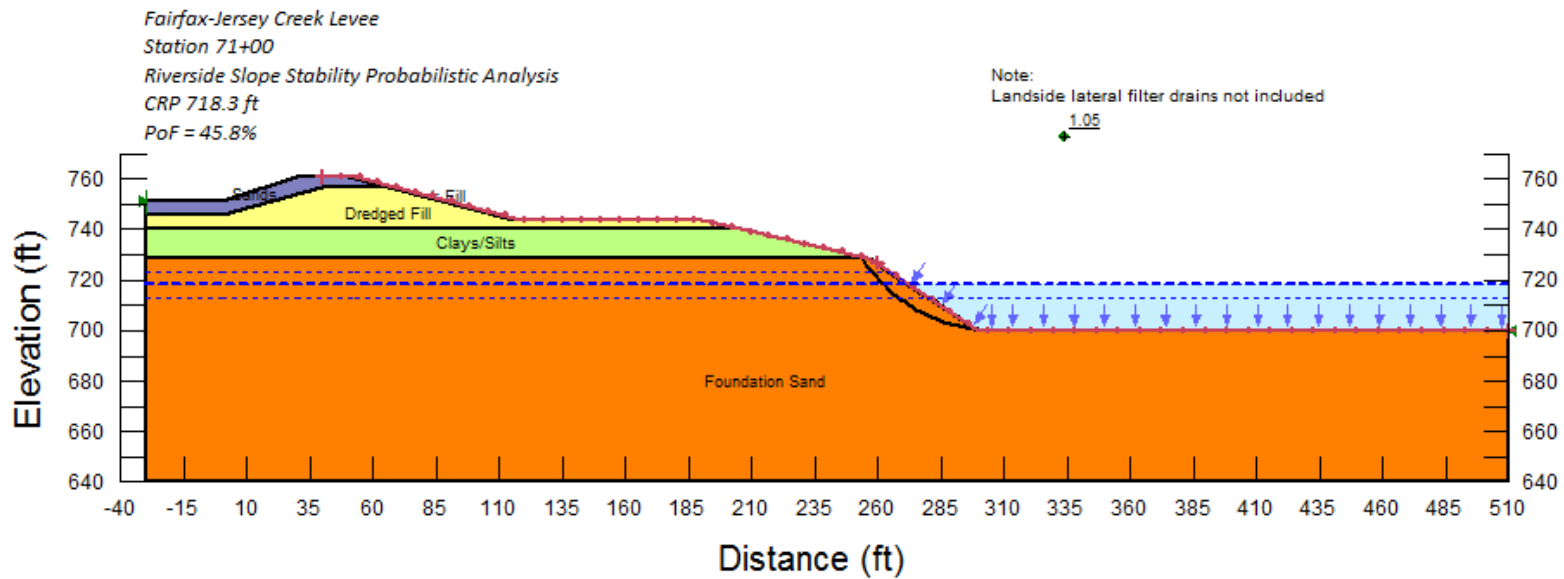
Figure 2.5.2-3: Riverside Slope Stability Results for Fairfax-Jersey Creek Levee Station 71+00 under Existing Conditions with Water Elevation at CRP

Name: Dredged Fill Model: Mohr-Coulomb Unit Weight: Multiple Trial: 100 pcf Cohesion: 0 psf Phi: Multiple Trial: 26 ° Piezometric Line: 1
 Name: Clays/Silts Model: Mohr-Coulomb Unit Weight: Multiple Trial: 115 pcf Cohesion: 0 psf Phi: Multiple Trial: 28 ° Piezometric Line: 1
 Name: Sands Model: Mohr-Coulomb Unit Weight: 115 pcf Cohesion: 0 psf Phi: 30 ° Piezometric Line: 1
 Name: Rock Fill Model: Mohr-Coulomb Unit Weight: Multiple Trial: 125 pcf Cohesion: 0 psf Phi: Multiple Trial: 35 ° Piezometric Line: 1
 Name: Foundation Sand Model: Mohr-Coulomb Unit Weight: Multiple Trial: 120 pcf Cohesion: 0 psf Phi: Multiple Trial: 34 ° Piezometric Line: 1

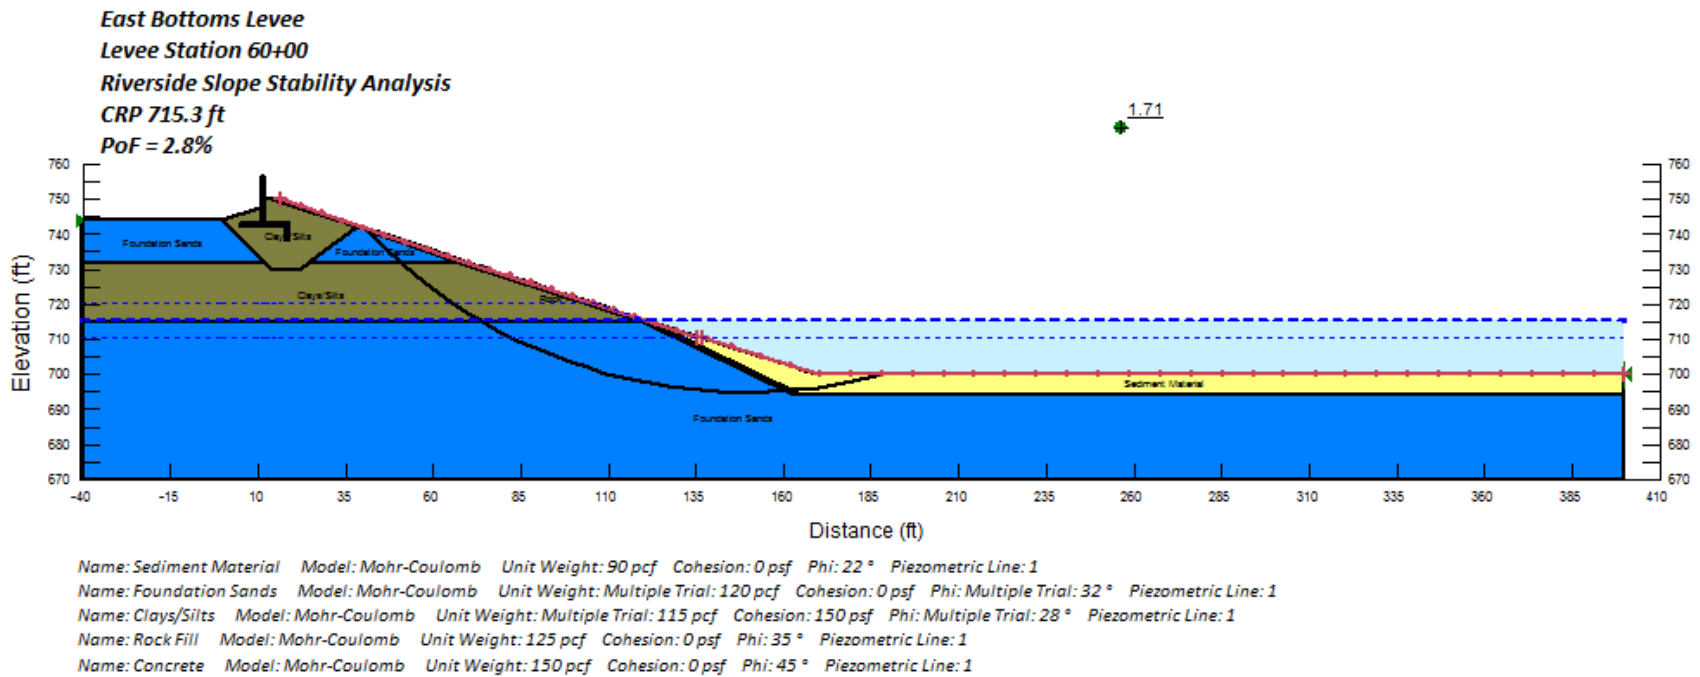
Figure 2.5.2-5: Riverside Slope Stability Results for East Bottoms Levee Station 60+00 under Existing Conditions with Water Elevation at CRP

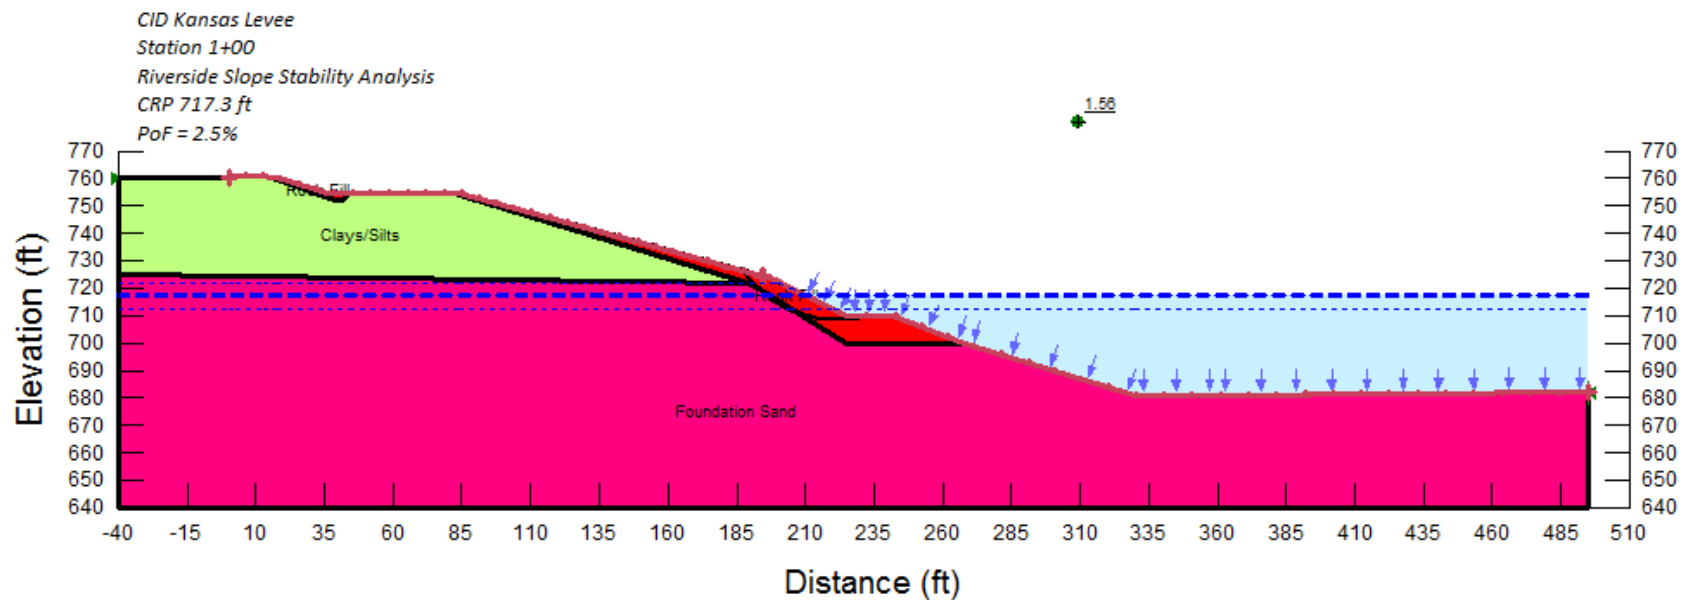
Figure 2.5.2-8: Riverside Slope Stability Results for CID Kansas Levee Station 1+00 under Existing Conditions with Water Elevation near CRP

Name: Clays/Silts Model: Mohr-Coulomb Unit Weight: Multiple Trial: 115 pcf Cohesion: 0 psf Phi: Multiple Trial: 28 ° Piezometric Line: 1
 Name: Rock Fill Model: Mohr-Coulomb Unit Weight: Multiple Trial: 125 pcf Cohesion: 0 psf Phi: Multiple Trial: 35 ° Piezometric Line: 1
 Name: Foundation Sand Model: Mohr-Coulomb Unit Weight: Multiple Trial: 120 pcf Cohesion: 0 psf Phi: Multiple Trial: 34 ° Piezometric Line: 1

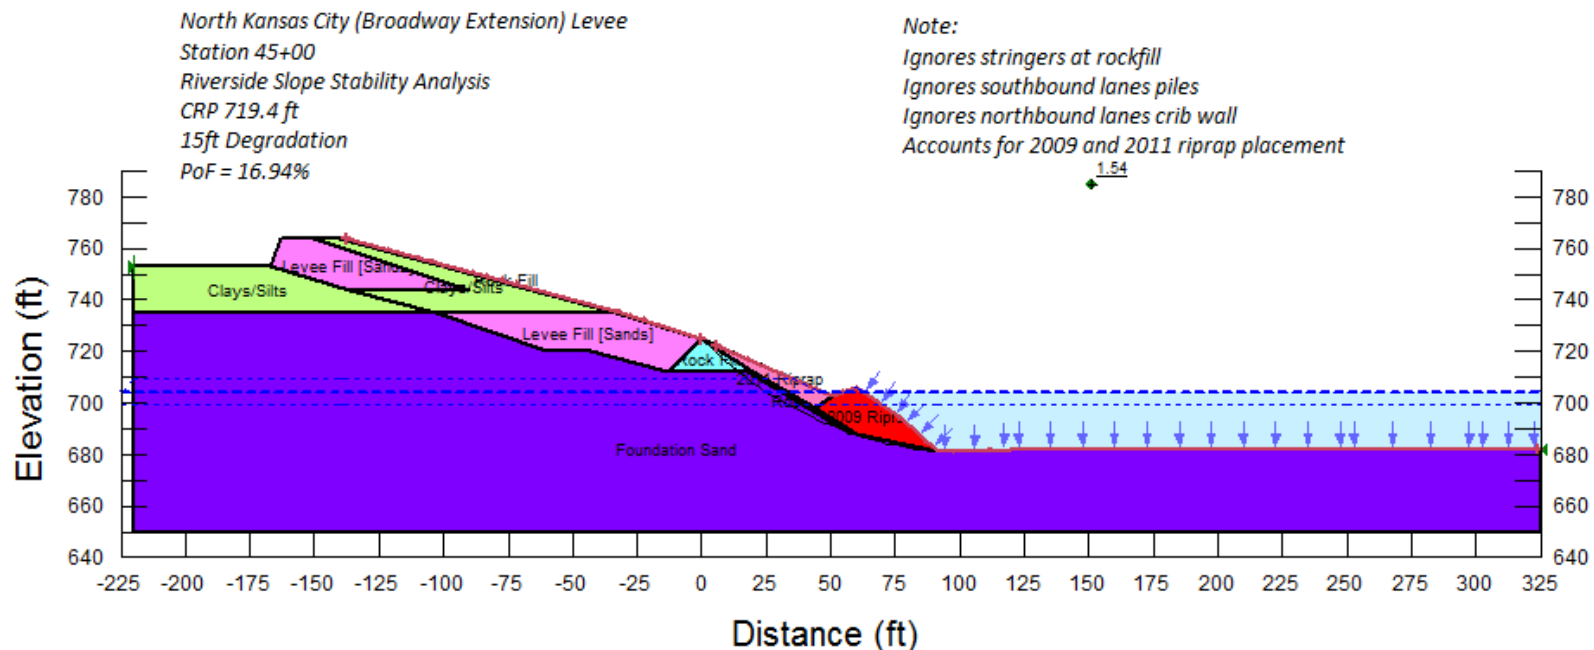
Figure 2.5.7-2: No Channel Bank Repair Required for the North Kansas City (Broadway Extension) Station 45+00 after 15 ft of Degradation under Future without Project Condition.

Name: Clays/Silts Model: Mohr-Coulomb Unit Weight: Multiple Trial: 115 pcf Cohesion: 0 psf Phi: Multiple Trial: 28 ° Piezometric Line: 1
 Name: Levee Fill [Sands] Model: Mohr-Coulomb Unit Weight: Multiple Trial: 115 pcf Cohesion: 0 psf Phi: Multiple Trial: 30 ° Piezometric Line: 1
 Name: Foundation Sand Model: Mohr-Coulomb Unit Weight: Multiple Trial: 120 pcf Cohesion: 0 psf Phi: Multiple Trial: 34 ° Piezometric Line: 1
 Name: Rock Fill Model: Mohr-Coulomb Unit Weight: Multiple Trial: 125 pcf Cohesion: 0 psf Phi: Multiple Trial: 35 ° Piezometric Line: 1
 Name: 2009 Riprap Model: Mohr-Coulomb Unit Weight: 135 pcf Cohesion: 0 psf Phi: 38 ° Piezometric Line: 1
 Name: 2011 Riprap Model: Mohr-Coulomb Unit Weight: Multiple Trial: 135 pcf Cohesion: 0 psf Phi: Multiple Trial: 38 ° Piezometric Line: 1

Creek wharf and North Kansas City levees in 2011. Typical outputs of levee performance after degradation for a given levee unit are shown in **Figures 2.5.7-2 through 2.5.7-7**.

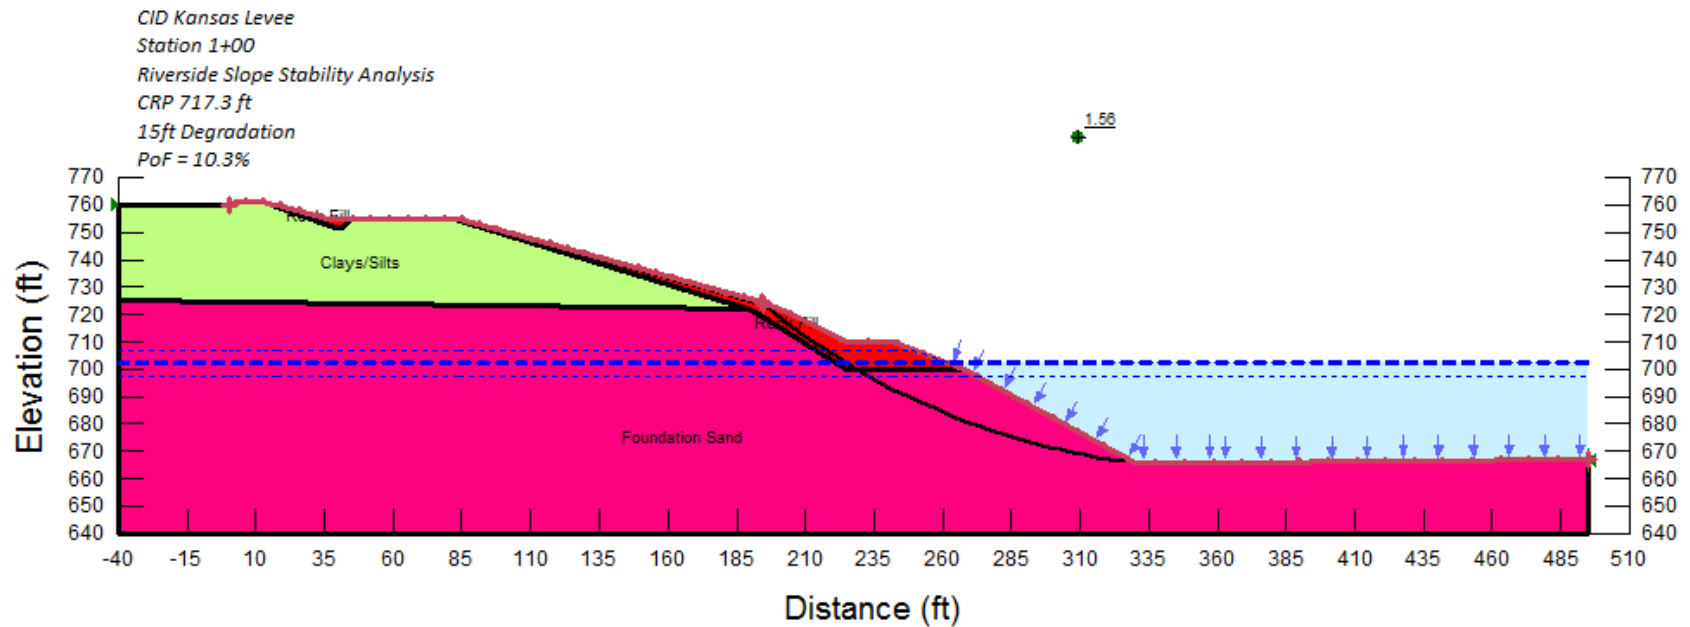
Figure 2.5.7-7: Typical Repair of Riverside Slope of CID Kansas Levee Station 1+00 after 15 ft of Degradation under Future without Project Condition at different Levels of Degradation.

Name: Clays/Silts Model: Mohr-Coulomb Unit Weight: Multiple Trial: 115 pcf Cohesion: 0 psf Phi: Multiple Trial: 28 ° Piezometric Line: 1
 Name: Rock Fill Model: Mohr-Coulomb Unit Weight: Multiple Trial: 125 pcf Cohesion: 0 psf Phi: Multiple Trial: 35 ° Piezometric Line: 1
 Name: Foundation Sand Model: Mohr-Coulomb Unit Weight: Multiple Trial: 120 pcf Cohesion: 0 psf Phi: Multiple Trial: 34 ° Piezometric Line: 1

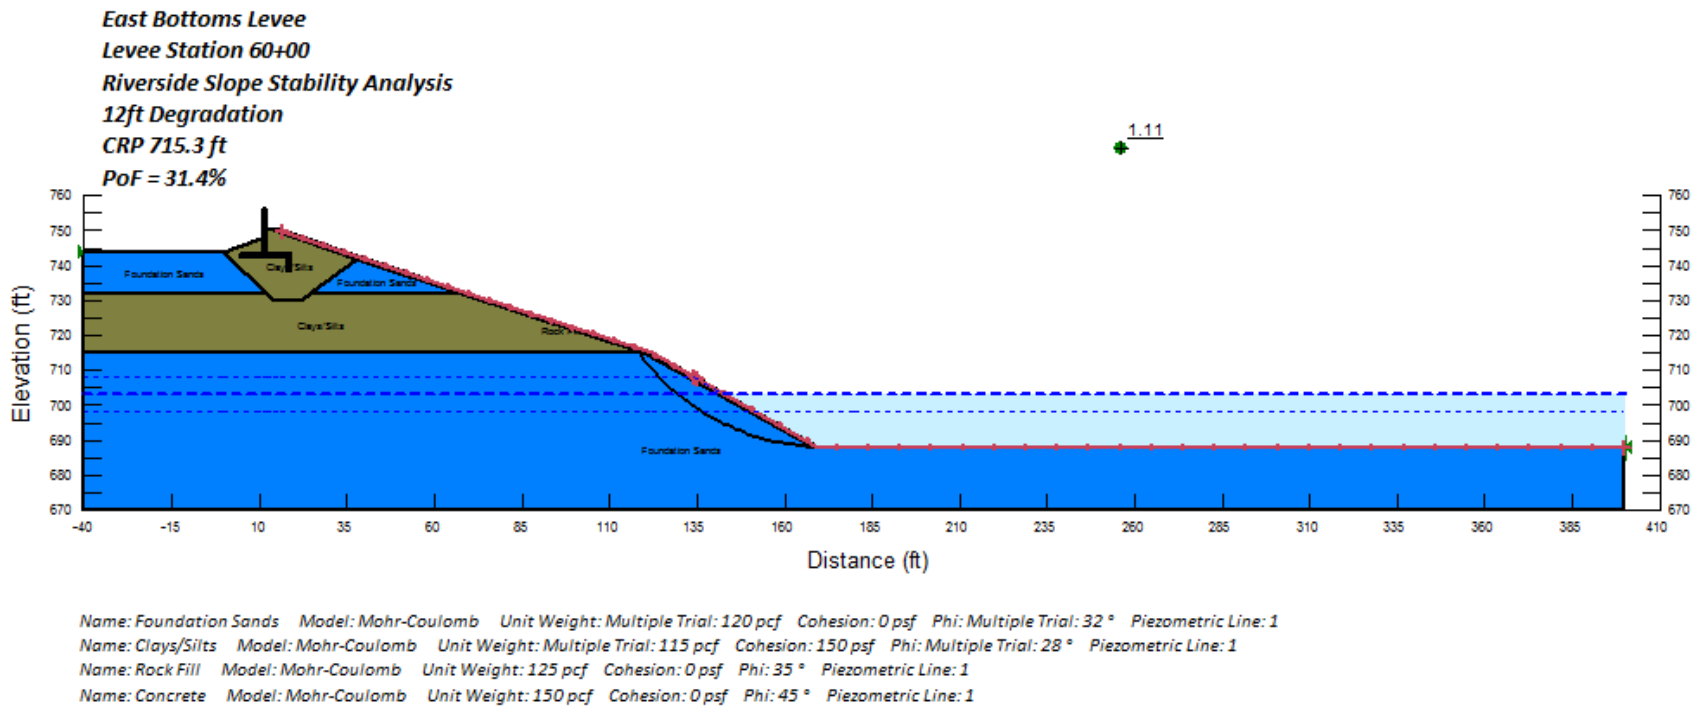
Figure 2.5.7-10: Worst Case Scenario of Neglecting Channel Bank Repairs until after 12 ft of Riverbed Degradation.

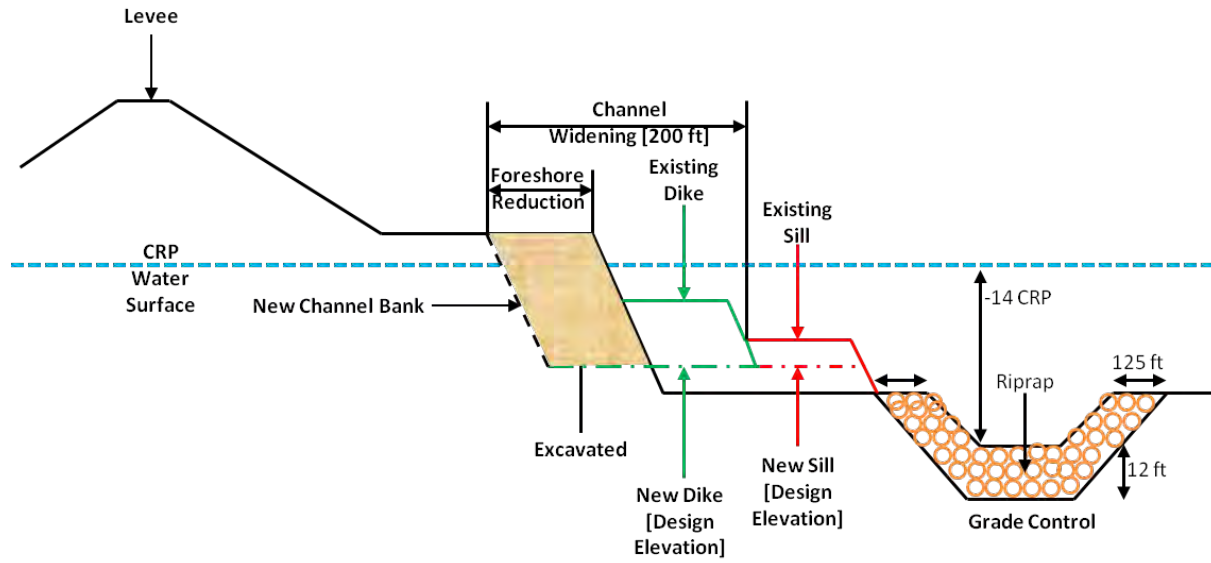
Figure 2.6.1-2: Schematic showing Alternative 5 with both dike and sill lowered to same elevation, 200 ft landward channel widening, and channel grade control

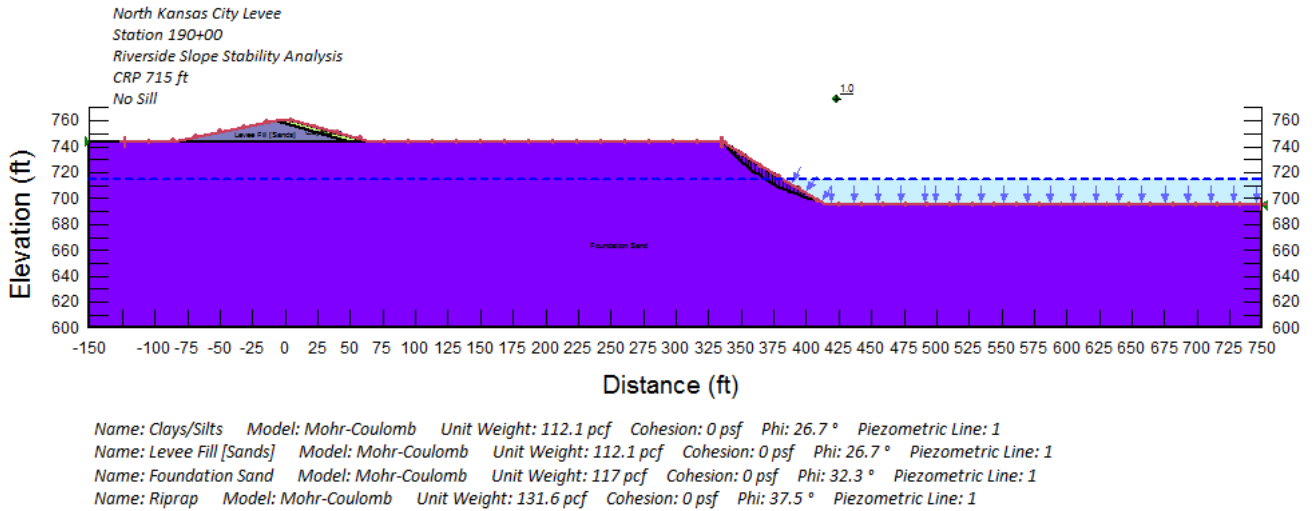
Figure 2.6.4-1: North Kansas City Levee Station 190+00 Stability under Future with Project Conditions at Location between Dikes/Sills

The outputs for the areas without the dikes/sills are shown in **Figures 2.6.4-1** through **2.6.4-4**. Outputs at the dike/sill locations are found in **Enclosure A.5**. As seen in **Tables 2.6.4-1** and **2.6.4-2**, the impact of the 200 ft channel widening associated with alternative 4 is insignificant for areas with and without dikes/sills for all the levee units except for the North Kansas City Airport levee. The channel slope along the North Kansas City Airport levee is less than the allowable FS of 1.4 but is equal to FS of 1.0 suggesting that the channel bank may be susceptible to shallow slides. Revetment of the channel bank along the North Kansas City Airport is recommended to address negative underseepage performance

Approximate River Mile	Station		Critical Station	Federal Levee	Factor of Safety [FS]
	From	To			
366.6	163+00	193+00	190+00	North Kansas City Airport	1.00
358.6	130+00	330+00	330+00	East Bottoms	1.83
358.6	94+00	104+00	104+00	Birmingham	1.65

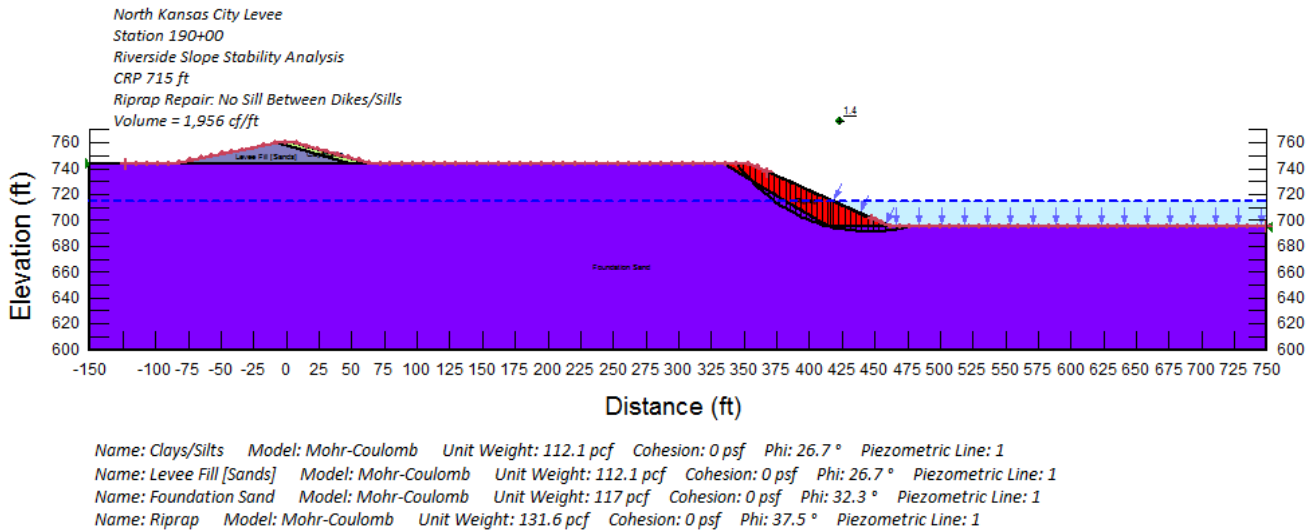
Figure 2.6.4-2: North Kansas City Levee Station 190+00 Channel Bank Repair under Future with Project Conditions at Location between Dikes/Sills

impact and future slope stability issues. The recommended revetment will require approximately 72 cubic yard/ft of riprap. Based on a unit price of \$49/ton/ft (2014 dollars), the revetment cost between Station 163+00 and 193+00 is roughly \$18,522,000.00.

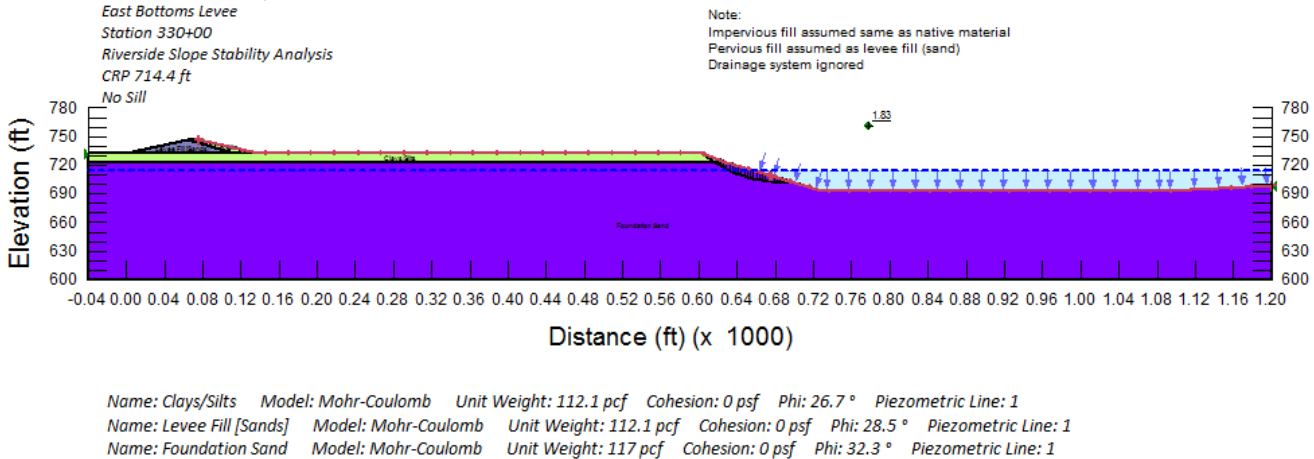
Figure 2.6.4-3: East Bottoms Levee Station 330+00 Stability under Future with Project Conditions at Location between Dikes/Sills
